# Manhole Inspection Summary

Manhole # S27G\_\_013MH

Insp Date: **5/23/08 9:01 AM**

**Location** Address: **1000 schroeder st**

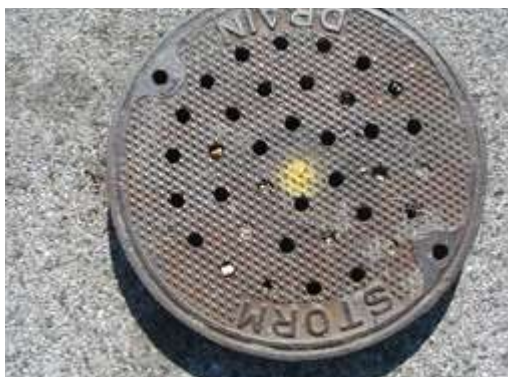
Incorrect cover

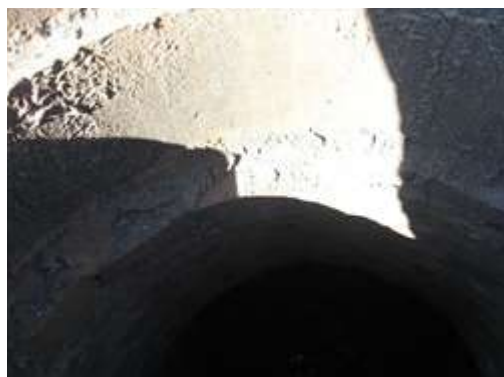
Defect 6

Offset: **1.5** (in.)

frame offset

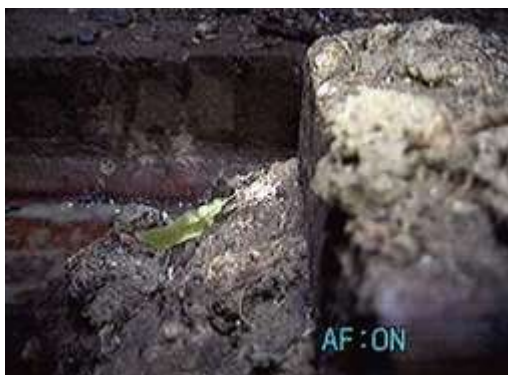
Defect 5

Condition: ☐ Sound ☐ Cracked ☐ Root Intrusion ☐ Deteriorated ☐ Leaks ☒ **Debris**

CHANNEL COND DEBRIS

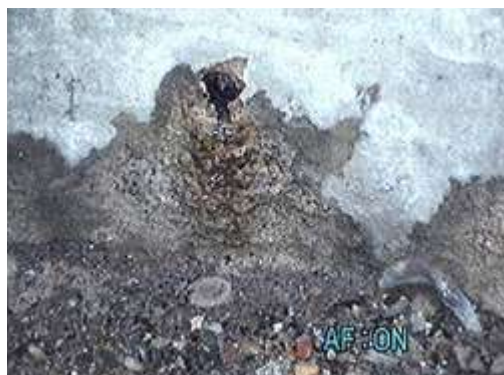
Defect 1

Condition: ☐ Sound ☐ Cracked ☐ Root Intrusion ☐ Loose Brick ☒ **Deteriorated**

Infiltration: ☐ None ☐ Joint ☐ Cracks ☐ Mortar ☐ Roots ☒ **Wall**

barrel deteriorated with infiltration from wall

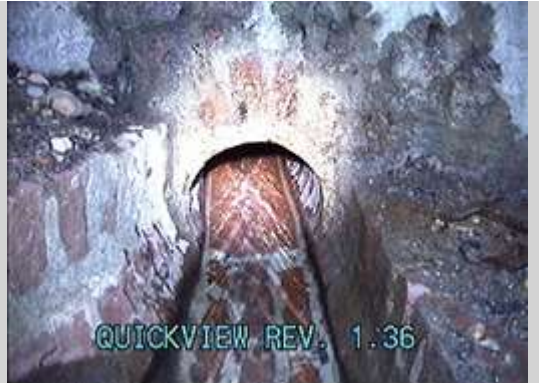
12 O'Clock Outflow

Pipe Height: **8.4** (in.) Rod and Bar (Angled)  
Pipe Material: **Clay** ☐ Pipe Lined  
Invert Depth: **10.18** (ft.) Flow Characteristics: **Fast**  
Deposits: ☒ None ☐ Mud ☐ Gravy ☐ Debris ☐ Grease  
Silt Depth: **0** (in.) Deposits Extent:  
Infiltration: **Evidence** Pipe Seal Cond: **Unknown**

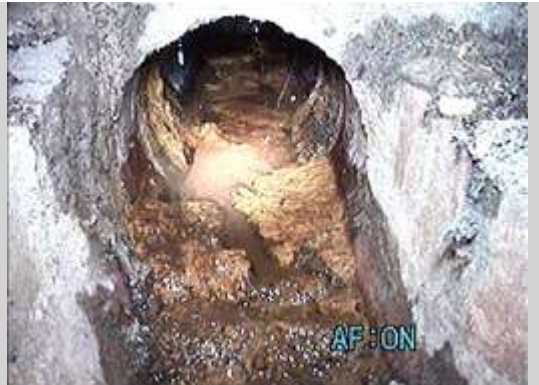
8 O'Clock Inflow

Deposits: ☐ None ☒ **Mud** ☒ **Sludge** ☐ Debris ☐ Grease

Silt Depth: **2** (in.) Deposits Extent: **Medium**

Infiltration: **Evidence** Pipe Seal Cond: **Unknown**
